Journal of Soft Computing in Civil Engineering

## A Comparative Review of Image Processing Based Crack Detection Techniques on Civil Engineering Structures

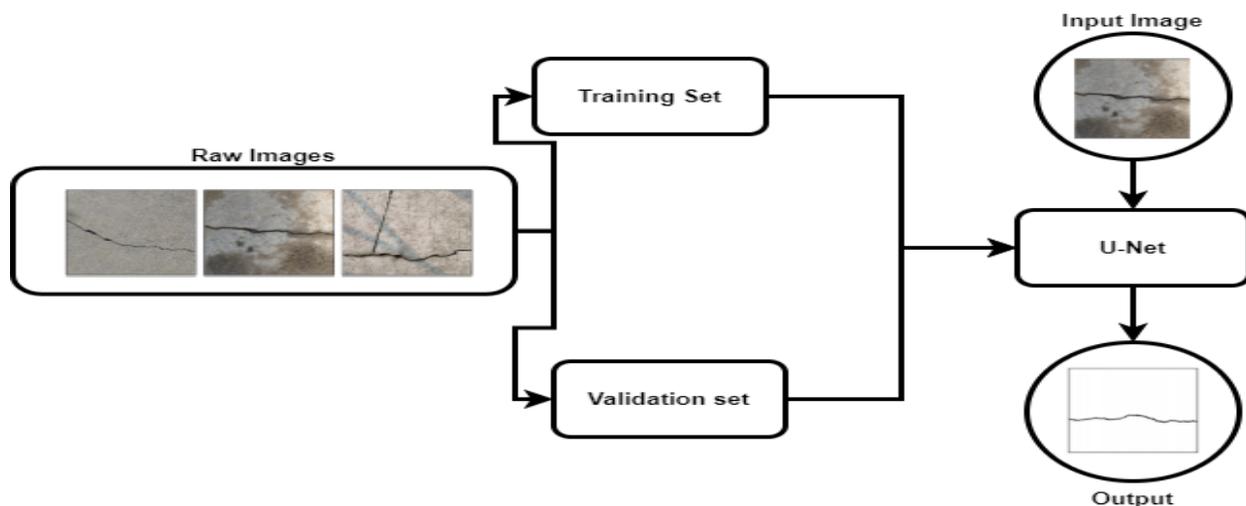
Liu et al. in 2019 [11], suggested a Full CNN based crack detection method using U-Net which is given in Fig. 5. Being, a deep neural network-based approach, for parameters tuning and hyper-parameters tuning the main dataset was divided into two parts, the training set and validation set. The 19 convolutional layered U-Net was trained with 57 input images from the training set. For the hyper-parameter tuning the rest of the images were used.

**Fig. 5.** CNN based crack detection using U-net [11].

The marked output images with defined cracks were received at the output layer after input images were inserted into the trained and tuned U-Net. Adam's optimizer and K-fold cross

validation were used for optimization and validation. As a result, a more efficient algorithm was developed.

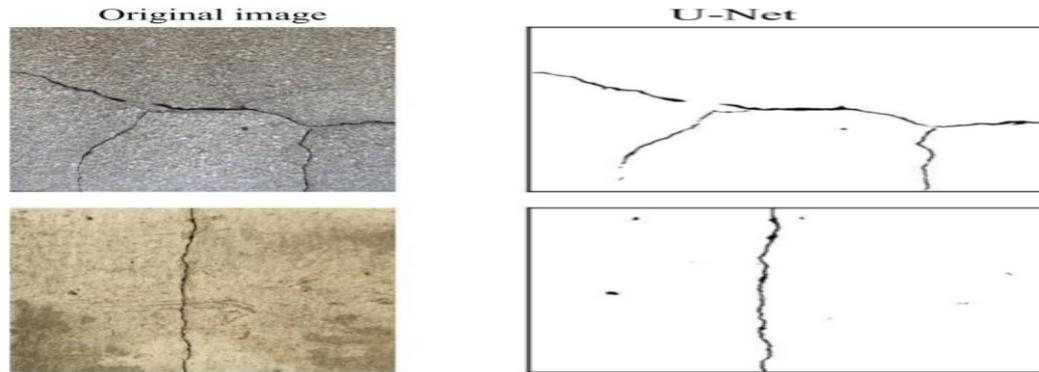
**Fig. 6.** Input original image (left) and U-Net image (right) [11].

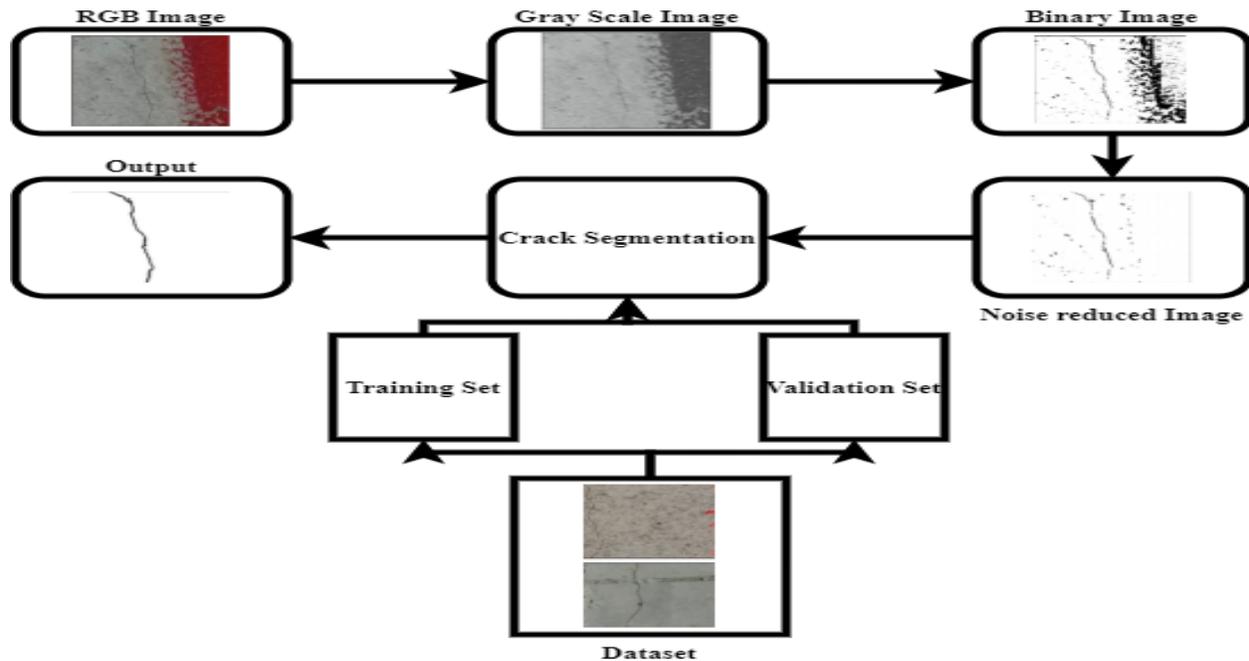
Ren et al. (2019) [12], suggested a crack detection system for tunnels using an improved fully convolutional neural network. CrackSegNet was the name of the network. The neural network was built using a modular design that included encoder, decoder path, and 3X3 convolutions, followed by a 2X2 max pooling layer. The 409 images in the input dataset were augmented to create a new larger dataset of 919 images. This dataset was split into a training set and a validation set in a 4:1 ratio for training purposes. The initial RGB images were converted to grayscale and binary images before being used in the detection process. Finally, they were subjected to noise reduction before being inserted into the network. The crack segmentation algorithm returned the images with only cracks being marked in binary form (Fig. 7).

**Fig. 7.** Work flow of CrackSegNet network to detect cracks [12].

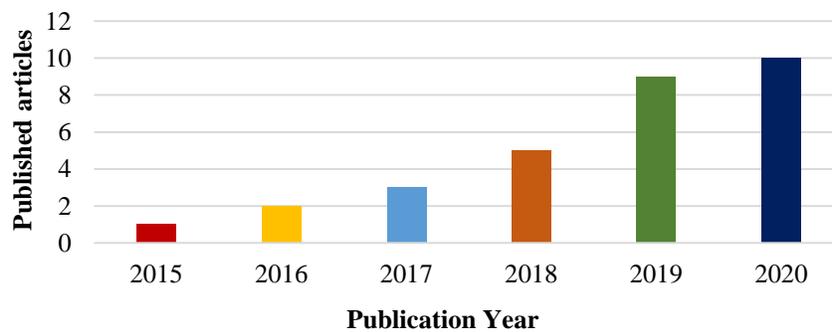
One of the very first papers on accurately evaluating and measuring values from concrete fractures was published in 2002. The experiment was carried out on concrete blocks [13]. Following that, multiple studies on crack detection using image processing were conducted. However, there has been a significant advancement in the algorithm and edge detection technique in the last six years. In recent years, proper edge detection and measurement of crack characteristics have been a significant concern. As a result, research papers were chosen based on the methodology and application of their research. Fig. 8 represents the publication frequency of the articles from 2015 to 2020, which has been analyzed in this review article.

**Fig. 8.** Frequency of published articles on crack detection in between 2015 - 2020.

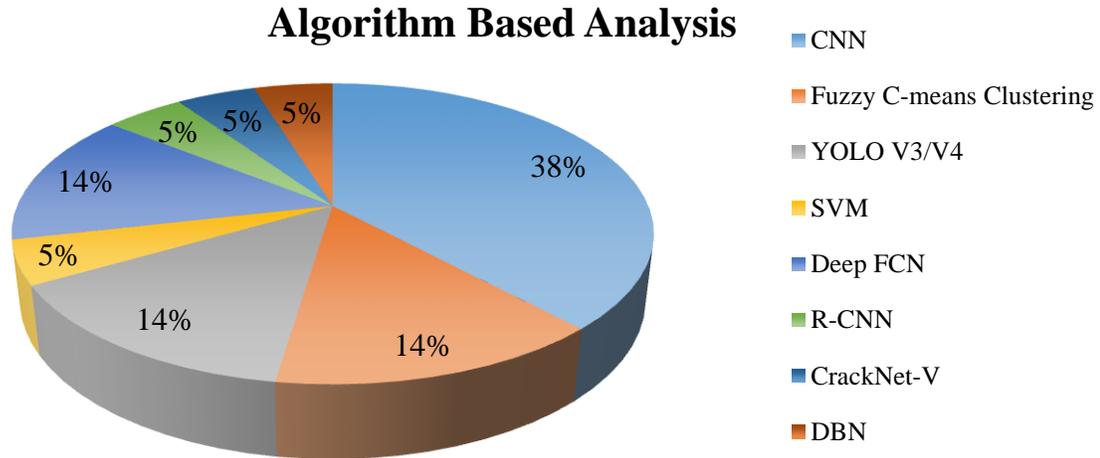
An algorithm based analysis was performed based on the results of the literature survey, and the outcome was used to form a pie chart in this section. Observing Fig.10, it can be seen that CNN (Convolutional Neural Network) algorithm has been used extensively for developing crack identification models. About 38% of literature has used CNN to develop their detection models, which is because of its low dependency on preprocessing and easier implementability. Fuzzy C-means Clustering, Deep FCN and YOLO V3/V4 algorithms were the subsequent most used algorithms with 14% usage among the papers, where YOLO is also a CNN based object detection algorithm. However, SVM, DBN, R-CNN and CrackNet-V were used at a low context of only 5%.

Fig. 10. Usage of different algorithms.

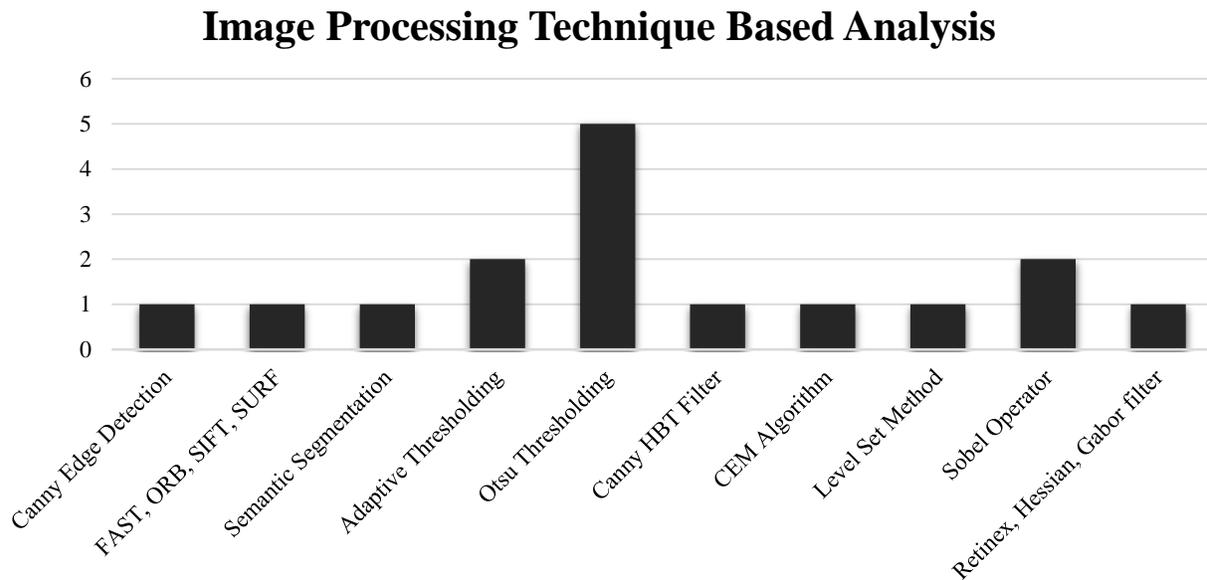
From the research articles reviewed, the image processing approaches were extracted to form a bar chart in order to demonstrate the number of usage. The bar chart highlighted that Otsu thresholding for image segmentation was the most commonly used image processing approach in the research articles, with five articles employing it. While adaptive threshold, another image segmentation approach and the Sobel operator method were only utilized in two of the publications, other techniques such as Canny edge detection, CEM algorithm, Level set method, and others were only employed in a single paper.

Fig. 11. Usage of different image processing techniques.

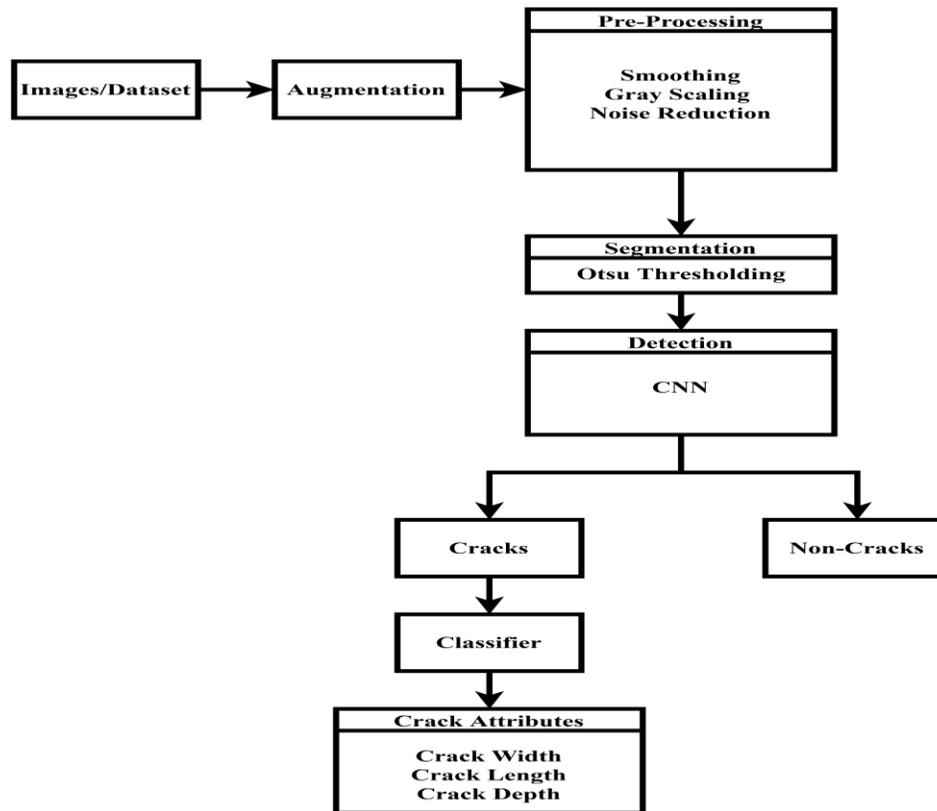
Image processing is the process of extracting key parameters from images in order to achieve a specific goal. An approach for image processing-based crack detection based on the information collected from reviewed research papers has been proposed in this survey study given in Fig. 12.

**Fig. 12.** Proposed approach for crack detection based on the results of the literature analyzed

The proposed approach is divided into 5 steps:

**(1)Image collection/ dataset creation:** The first step in the approach is to gather crack images and create a dataset.

**(4)Crack detection:** In this stage, detection algorithm such as Convolutional Neural Networks can be used to detect either crack or non-crack images.

**(5)Detection of crack attributes:** The final step involves using classifiers again for the purpose of detection of crack length, width and depth.
